- SUBJECT:** Hartzell Engine Technologies (HET) Alert Service Bulletin (ASB) No. 081A
- PURPOSE:** To notify owners, operators, distributors, and maintenance facilities of inspection criteria for affected Hartzell alternators; Continental P/Ns 641668, 641670, and 656802.
- COMPLIANCE:** Compliance may be required prior to further flight. Reference attached Hartzell Engine Technologies (HET) Alert Service Bulletin (ASB) No. 081A.
- MODELS**
- AFFECTED:** New and rebuilt Continental GTSIO-520-C, N; IO-520-B, BA, BB, C, CB; IO-550-A, B, C, G, N, P, R, IOF-550-B, C, N; TSIO-520-B, BB, D, DB, E, EB, NB, UB; TSIO-550-B, C, E, G, J, K, N; TSIOF-550-D, J, K, P and TSIOL-550-B aviation gasoline (AvGas) engines.

DOC NO **REVISION**
CSB19-06

ALERT SERVICE BULLETIN No. 081 Rev. A

Alternator Castellated Hex-Nut Inspection

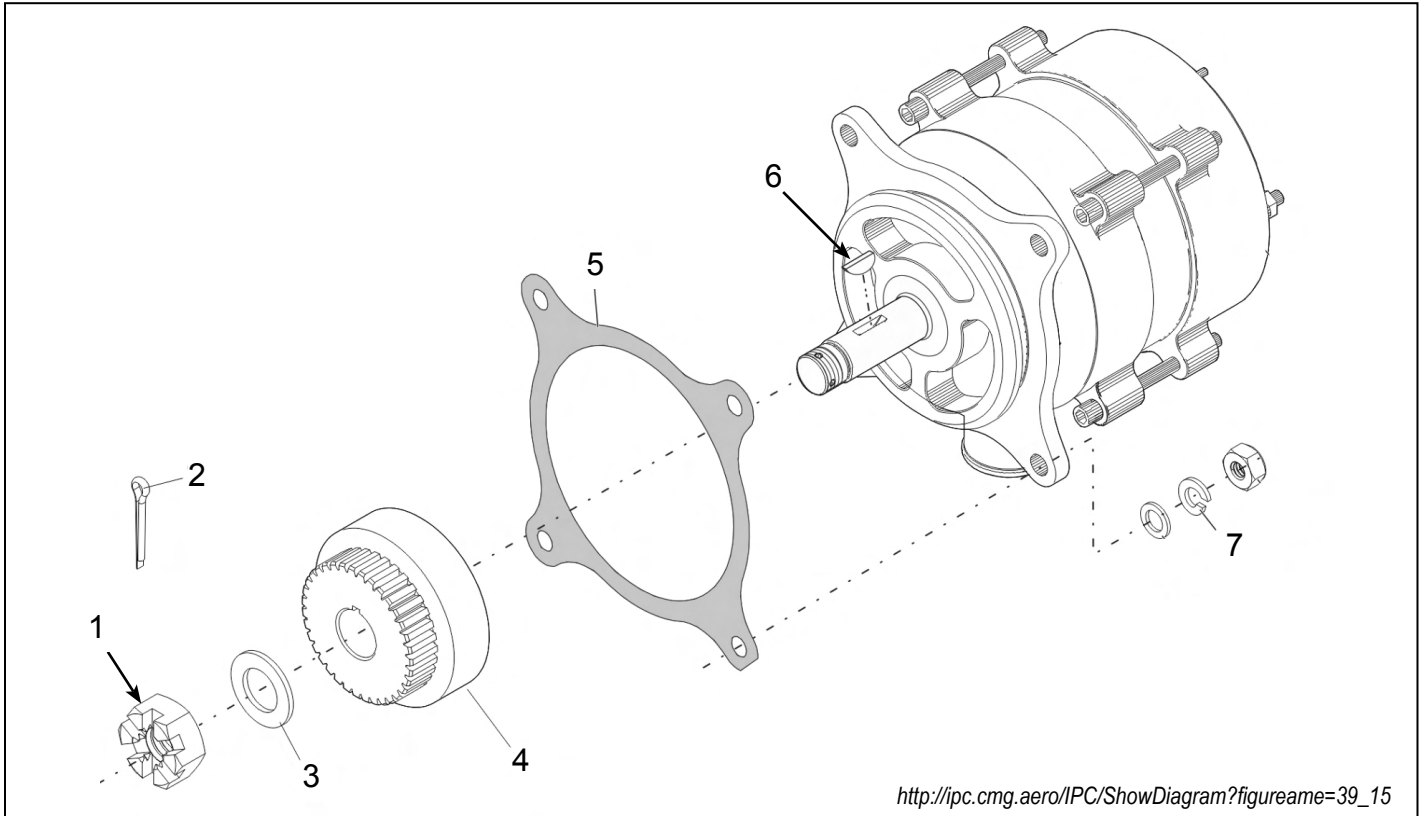
Figure 1 - Alternator, Typical - Continental Aerospace Technologies

- (1) Alternators listed in section 1.A could contain a castellated hex-nut (1, Figure 1) that does not torque flush with the thrust washer (3). This condition could compromise the integrity of the drive coupling retention system.
 - (a) Loss of drive coupling retention may result in engine damage and/or unexpected loss of engine power.
- (2) This ASB is to advise the field of a known condition and to supply inspection criteria to identify affected alternators.

- (5) Remove and discard from alternator; cotter pin (2), castellated hex-nut (1), thrust washer (3), and woodruff key (6). Refer to Figure 1.
- (6) Inspect drive coupling (4) in accordance with applicable service instructions.
- (7) Install new replacement components not affected by this ASB onto the alternator in accordance with applicable engine manufacturer's maintenance manual. Refer to Table 1 - Materials Required.

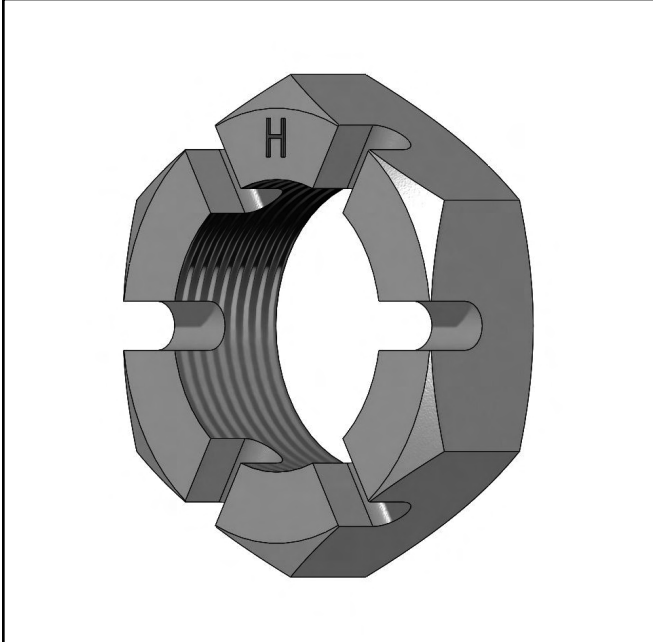
Figure 3 - Laser Etched "H"

- (1) Remove the alternator from the engine in accordance with the latest revision of the aircraft and/or engine manufacturer's maintenance manual.
- (2) Inspect castellated hex-nut (1). If one of the following indicators is present, the alternator is in compliance with this ASB. Refer to Figures 3 thru 5.
 - (a) Hex-nut (1) is laser etched with the letter "H";
 - (b) Hex-nut (1) is stamped with a center-punch;
 - (c) Hex-nut (1) is roll-stamped with the letters "AD".
- (3) If any indicator stated above **is not** present, proceed to 3.B.(4). If one of the indicators stated above **is** present, continue to 3.B.(8).
- (4) Using a .002 in. (.0508 mm) feeler-gauge, measure the gap between the nut thrust face and the thrust washer at each of the six hex-nut flats. Refer to Figure 6.

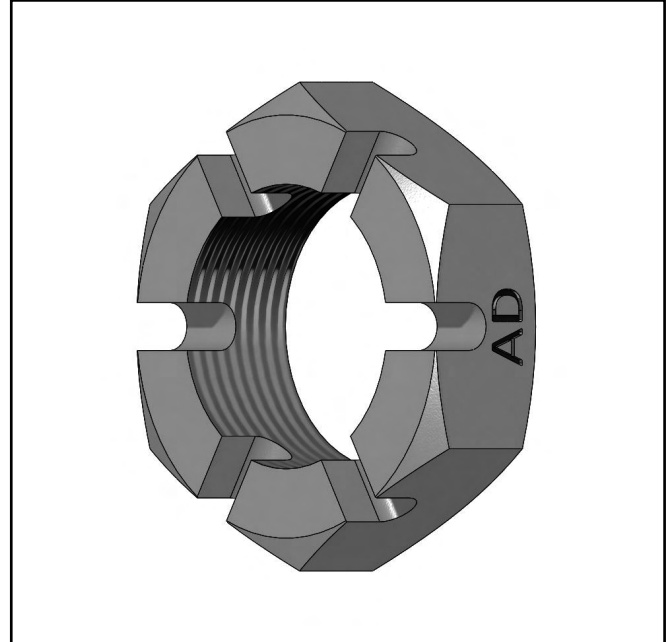
Figure 4 - Roll-Stamped "AD"

- B. Revise 3.B.2.(c) to reflect change to Figure 4:
 - (1) Change to: Hex-nut (1) is roll-stamped with the letters "**AD**".
 - C. Add task 3.B.(6) for clarification:

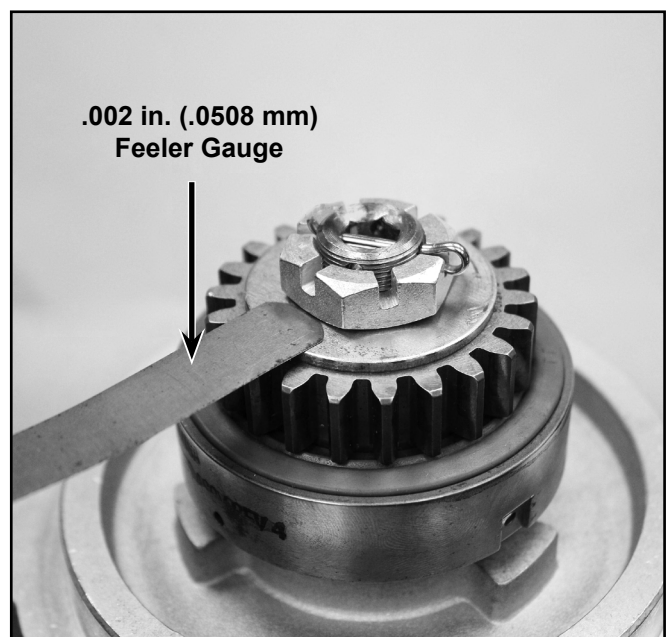
Figure 6 - Gap Measurement

- (a) If the measurement at any nut flat is \geq .002 in. (.0508 mm), continue to 3.B.(5).
- (b) If the measurement at each nut flat is $<$.002 in. (.0508 mm), no corrective action is required.
 - 1) Using an automatic center punch, punch the face of the hex-nut (1) so that it will be easily identified for future reference (Refer to Figure 5). Continue to 3.B.(8).
