POWER PLANT - TRANSMITTAL OF CONTINENTAL AEROSPACE TECHNOLOGIES SIL21-04B

SEL-71-16
Page 1 of 2

SIL21-04B

SUBJECT: Improved Rocker Cover Gasket, Part No. 668893

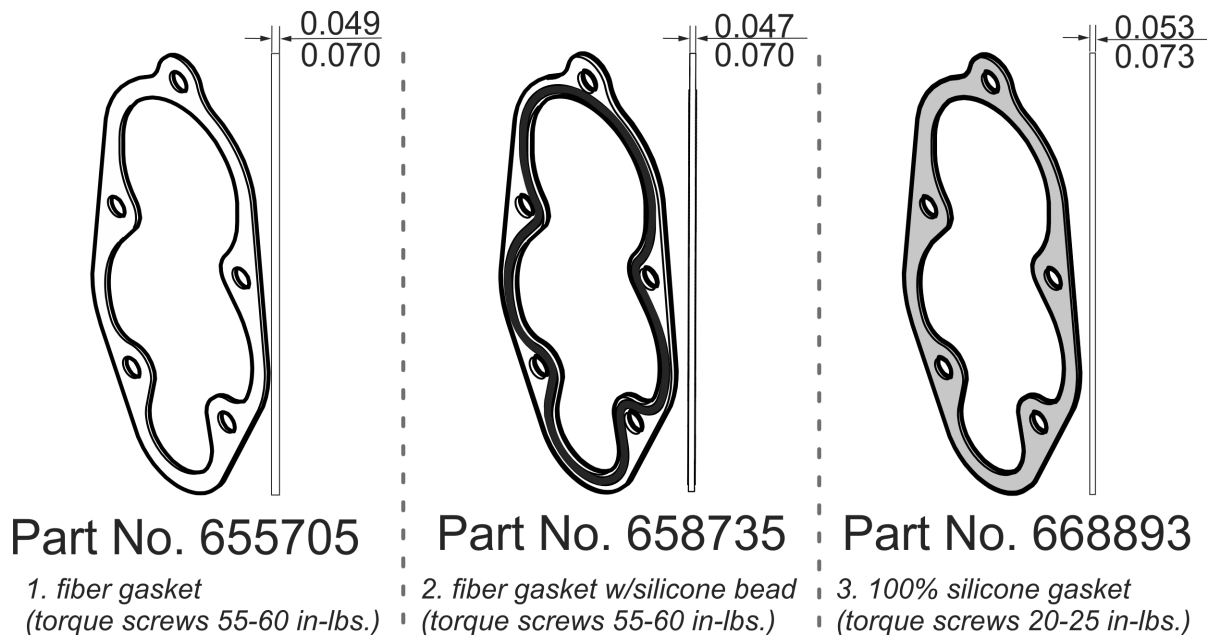
Figure 1. Gasket Comparison

Rocker Cover Gasket Part No. 668893 is a flexible, silicone gasket, smooth on both sides; no special mating instructions apply. Rocker Cover Gasket Part No. 658735 is a fiber gasket with a silicone bead on both sides of the gasket. Gasket Part No. 655705 (preceded Part No. 658735) and previous gaskets used with crossflow style cylinders were fiber gaskets with no bead. Earlier gaskets were subject to age control; Part No. 668893 is not.

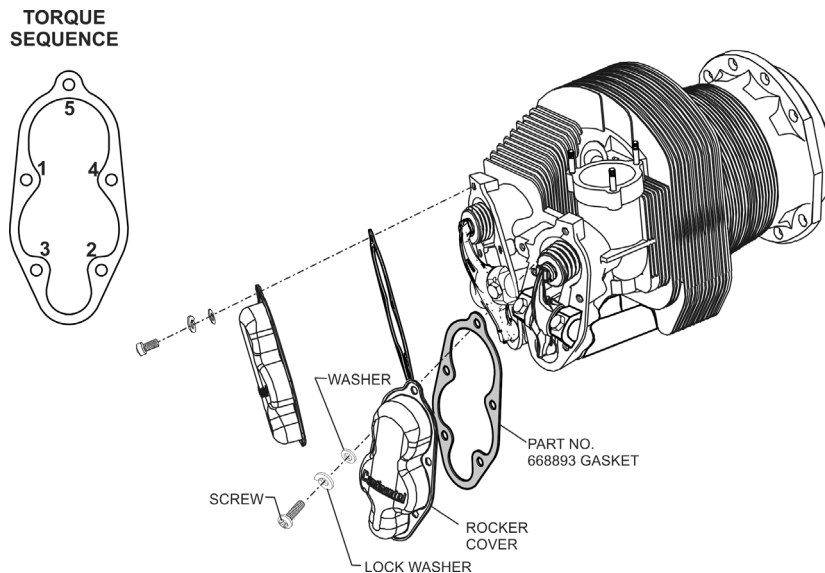
Figure 2. Rocker Cover Installation

CAUTION: Failure to clean the rocker and cover flanges will cause leaks. Surfaces must be clean and oil-free to seal properly. Applying 55-65 in-lbs. torque to rocker cover fasteners using Rocker Cover Gasket Part No. 668893 will damage the gasket and rocker cover.

1. Clean the rocker box (including threaded screw holes) and cover flanges thoroughly with isopropyl alcohol (IPA) or acetone before installing the gasket to remove oil and old gasket residue. Clean the rocker cover screw threads with a wire brush and rinse with IPA or acetone.
2. Install rocker cover(s) with new gasket according to instructions in the primary ICA.
3. Sparingly apply a thin bead of Continental Part No. 658517 (Loctite® 243) across the rocker cover screw threads according to the manufacturer's instructions. Secure each rocker cover with five screws and torque the screws in an alternating pattern (see Figure 2):

- a. On rockers using gasket Part No. 668893, torque cover screws 20-25 in-lbs.
- b. On rockers using any fiber gasket, torque cover screws 55-60 in-lbs.
